HOW TO FIX A LOSS OF SUPERVISION PROBLEM ON THE SENSOR(NOWDSF360)

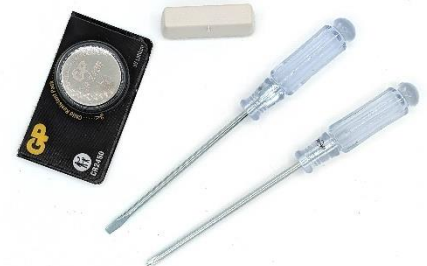
Necessary Equipment:

- Magnet
- Phillips Precision Screwdriver (Star) #00
- Flat screwdriver

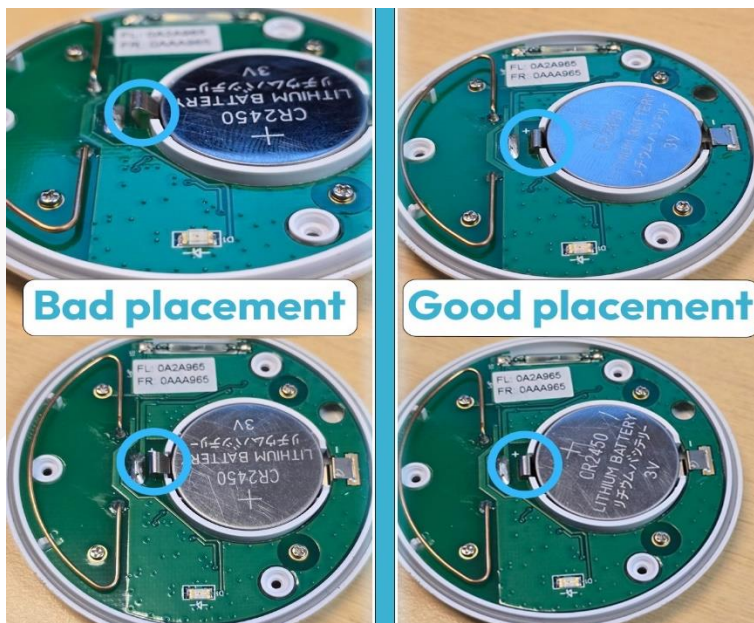
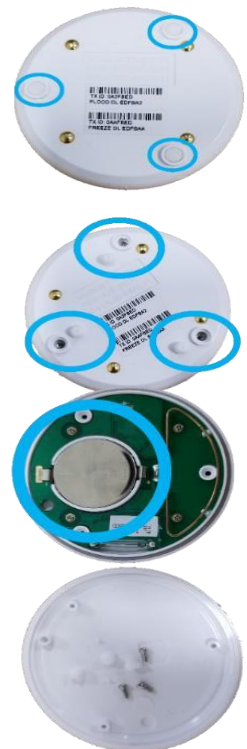
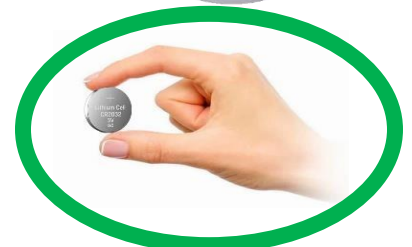
1. Using your small flat screwdriver, remove each of the small plugs located in the center of each leg of the wireless detector, so that you can see each of the star screws.
2. Unscrew these three small screws from the detector legs using the Philips screwdriver.
3. Lift the upper part of the detector, so that it is separated into two parts.
4. Remove the CR2450 battery by gently lifting it using your flathead screwdriver.
5. **Replace the CR2450 battery** in the slot provided for this purpose, **making sure you see the positive side of the battery.**
6. **Make sure to push the metal tab back as far as it will go (See illustration)**

7. Place the top and bottom of the detector back together, making sure the gasket is in place. To do this easily, **align the lines that appear on the side of each part of the detector.** This will make it easier to put the small screws joining the two parts back in place in the right place.
8. Screw in the small star screws.
9. **Replace the three small** plugs in the center of each of the detector legs to hide the star screws.
10. **Take the magnet and tap it on the line formed on the side of the detector then remove the magnet.**
Note: If your detector is configured as gel, follow the same step, but this time, hold the magnet in place for 5 seconds.
11. If the magnet is strong enough, your control panel will then notify you of a tamper alarm and correct the low battery signal.
12. You can then press **“Reset”** to cancel the alarm and press **“Open valve”** to reopen the valve.
